Manhole Inspection Summary

Manhole # S29M__026MH

Location Address: **Scott St**

Cross Street: **Carroll St**

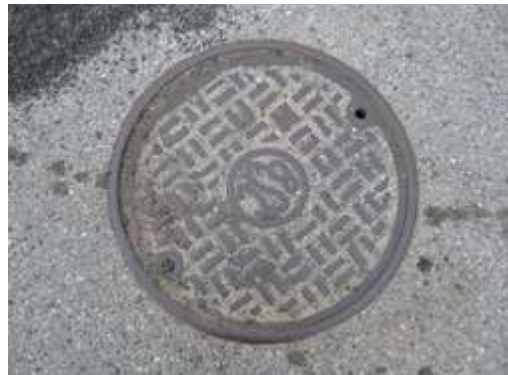
cover pic

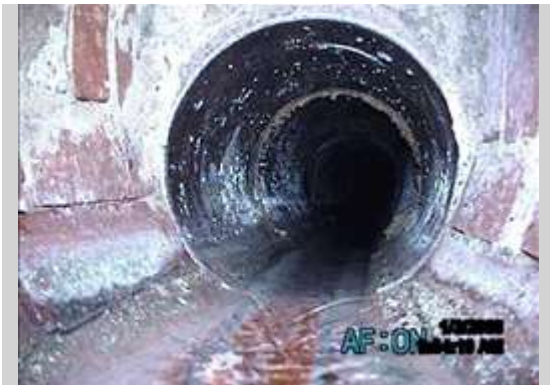
9 O'Clock Inflow

8 in. Circular Gravity Sewer
Pipe In @ 9 O'Clock

Pipe Height: **8.4** (in.) Rod and Bar (Angled)
Pipe Material: **Clay** ☐ Pipe Lined
Invert Depth: **9.10** (ft.) Flow Characteristics:
Deposits: ☐ None ☐ Mud ☐ Sludge ☐ Debris ☐ Grease
Silt Depth: **0** (in.) Deposits Extent:
Infiltration: Pipe Seal Cond:
